District of Columbia
Fire & Emergency Medical Services
Department

Report from the Reconstruction Committee

Fire at
3146 Cherry Road, NE
Washington, DC

May 30, 1999

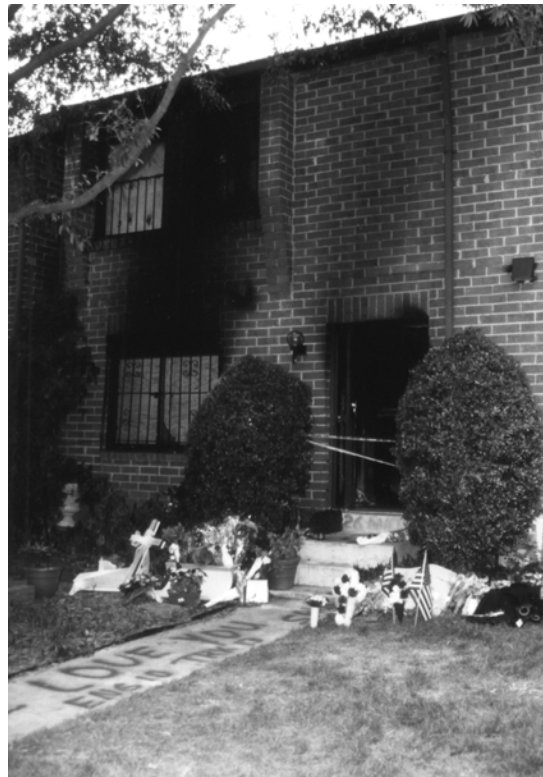
Photo 1 Front of 3146 Cherry Road, N.E.

The structure at 3146 Cherry Road, N.E. was a row townhouse, built into a hillside with two stories visible in the front and three stories visible in the rear. The building was approximately 33 feet long and 19 feet wide. The structure consisted of wood frame construction with non-combustible masonry firewalls and energy-efficient features, specifically, double-paned windows and sliding glass doors. The flooring was supported by an open web wooden truss of 2 x 4 lightweight assembly that was held together with gusset plates. The basement trusses were enclosed by plywood on top and combustible ceiling tile below. Two steel I-beams and multiple columns supported the first floor. The dimensions of the basement, first and second floors are the same. The most notable feature of the exterior of the building is that it appears to be a two-story structure from the front and a three-story structure from the rear.

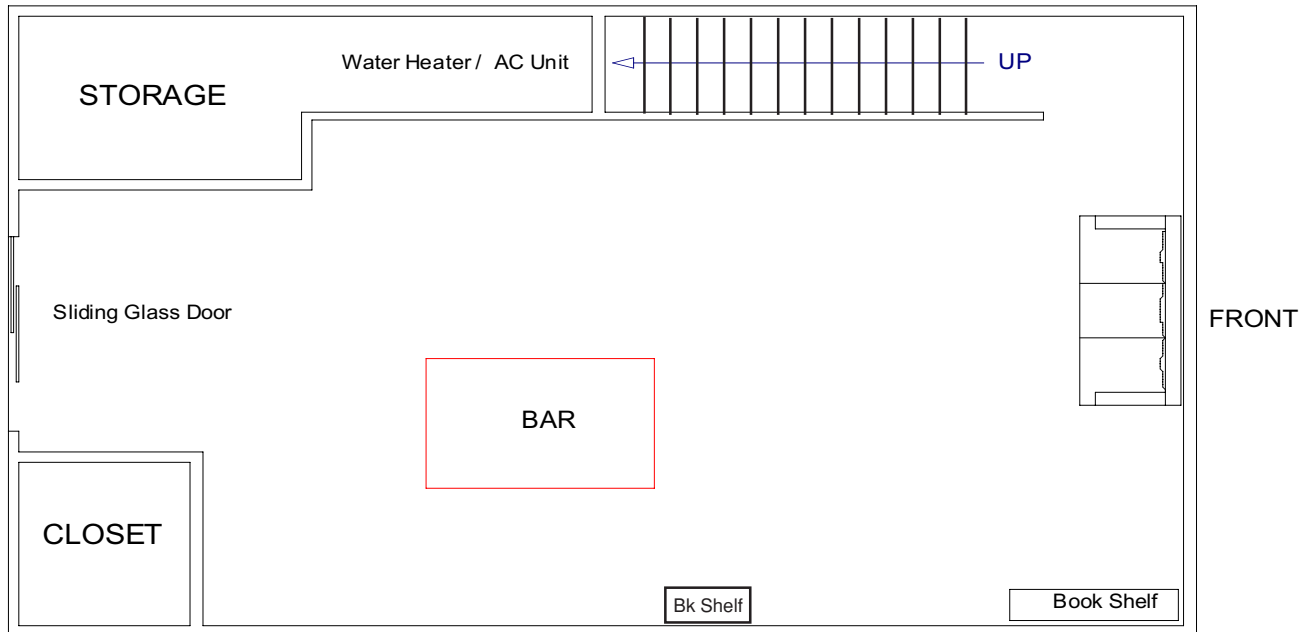
Figure 1 Basement floor plan (Not to scale)

A six-foot wooden and masonry fence enclosed a small brick patio in the rear of the structure. The finished basement was accessible through either an interior stairwell or through a rear sliding glass door that opened to the patio. The double-paned sliding glass door had locked security bars in place. There were no windows in the basement. The basement had a combustible drop ceiling with both cellulose and fiberglass insulation in the space between the drop ceiling and the first floor.

A junction box wired to a fluorescent light fixture affixed to the basement ceiling was identified as the origin of the fire by investigators. The fire origin and cause report is included in Appendix C.

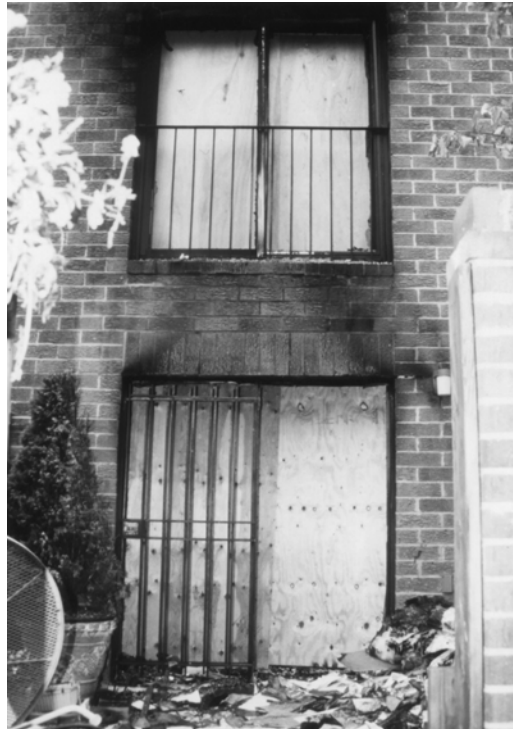
Photo 3 Sliding glass doors and security bars as viewed from inside the patio fence.

The T-4 crew noted that the fire appeared to be running out of air. Truck 4's officer and fire fighter removed the security bars and broke the sliding glass door. At that time, T-4's driver and tiller person placed a ground ladder at the rear of the structure in an unsuccessful attempt to ventilate the rear second floor windows. No attempt was made by T-4, or any other units, to ventilate through the first floor sliding glass door. The evidence has shown that the ventilation through the basement sliding glass door was a premature and uncoordinated action because it was done before a rear hose line could be advanced into the structure and before receiving permission to attack the fire from the Incident Commander.

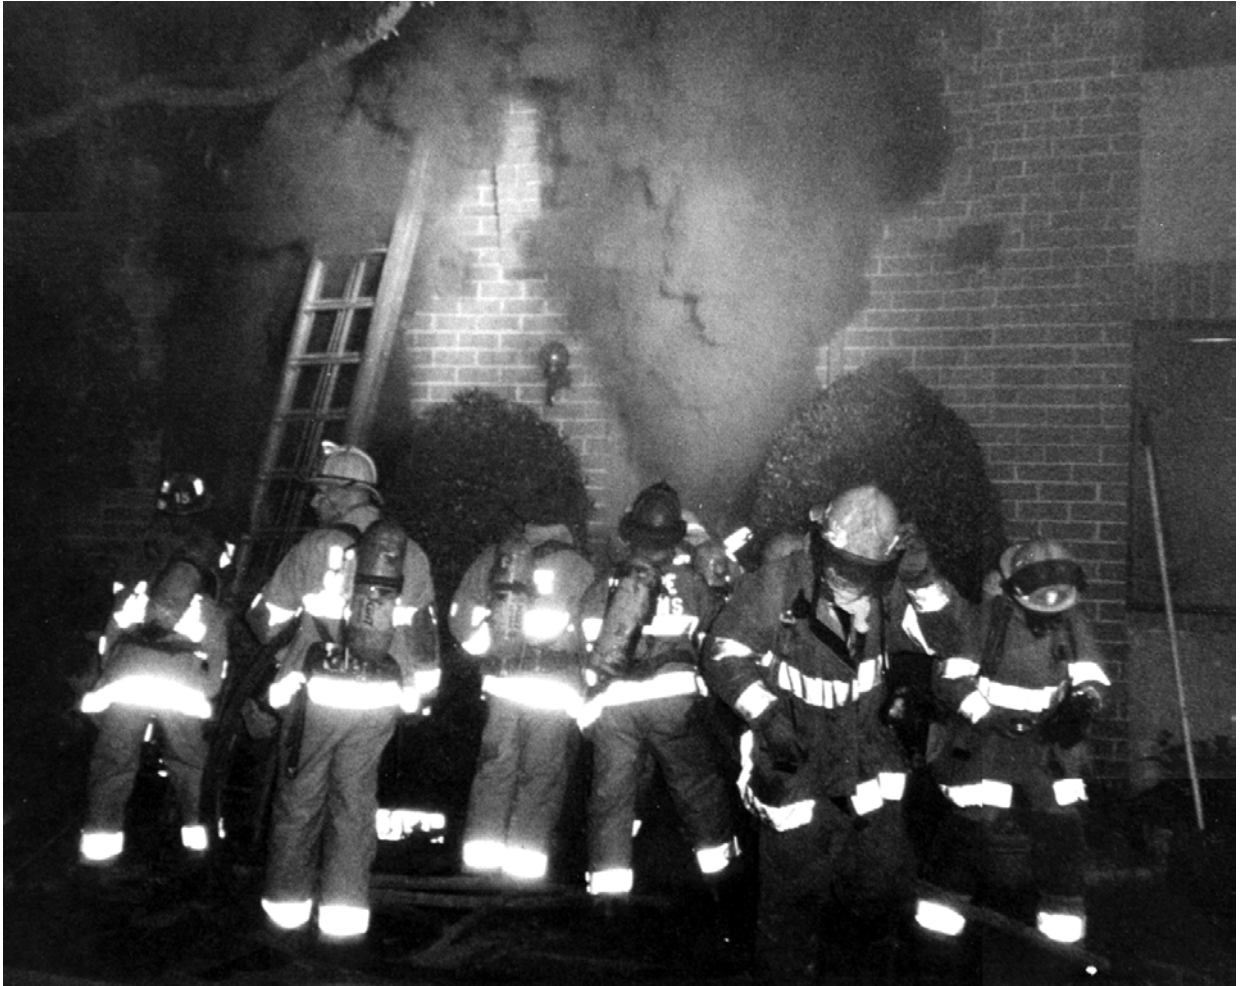
Photo 5 Front of building as conditions deteriorate

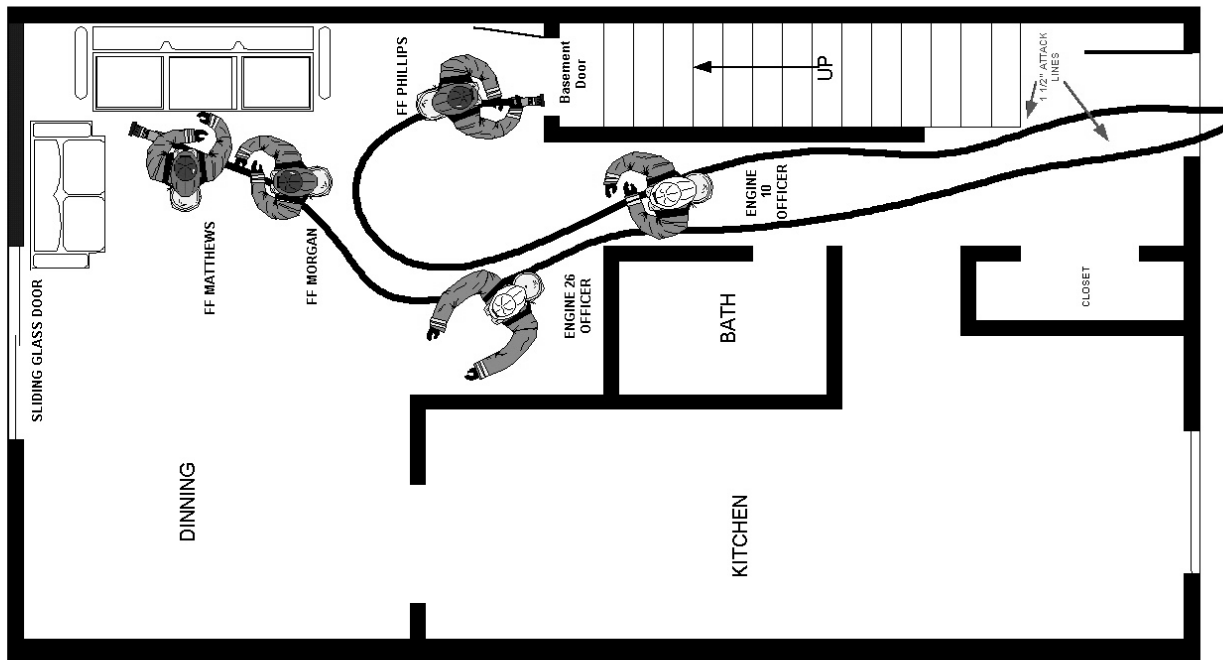
The evidence has shown that it was F/F Phillips (E-10) who extinguished the visible fire on the first floor with two quick hose line bursts. Fire Fighter Phillips was unknowingly located in close proximity to the open basement stairway door. Fire Fighters Morgan and Matthews from E-26 were located toward the rear of the building and approximately in line between the open basement door and the first floor sliding glass door (see Figure 4). The super-heated fire gases in the basement ignited and traveled up the basement stairs at a high speed to an inadequately ventilated first floor. The basement stairway acted as a chimney for the fire, which had evolved from a smoldering state to a free burning, fully involved basement fire within seconds. For further information on the fire dynamics, see the NIST report in Appendix D.

Figure 4 Position of fire fighters at time of rapid heat release (Not to scale)

Evidence indicates that F/F Phillips (E-10) was in direct contact with flame as well as with super-heated gases. Fire Fighter Morgan (E-26) recalled that he and F/F Matthews were not exposed to direct flames; however, he does recall seeing flames fill the doorway before the room went dark and became extremely hot. As extreme heat blanketed Fire Fighters Morgan and Matthews, they became separated from their hose line. F/F Morgan recalled that he asked F/F Matthews “where is the line?” and stated “we’ve got to get out of here.” The Reconstruction Committee has concluded that the fire fighters were burned at approximately 00:28:00.

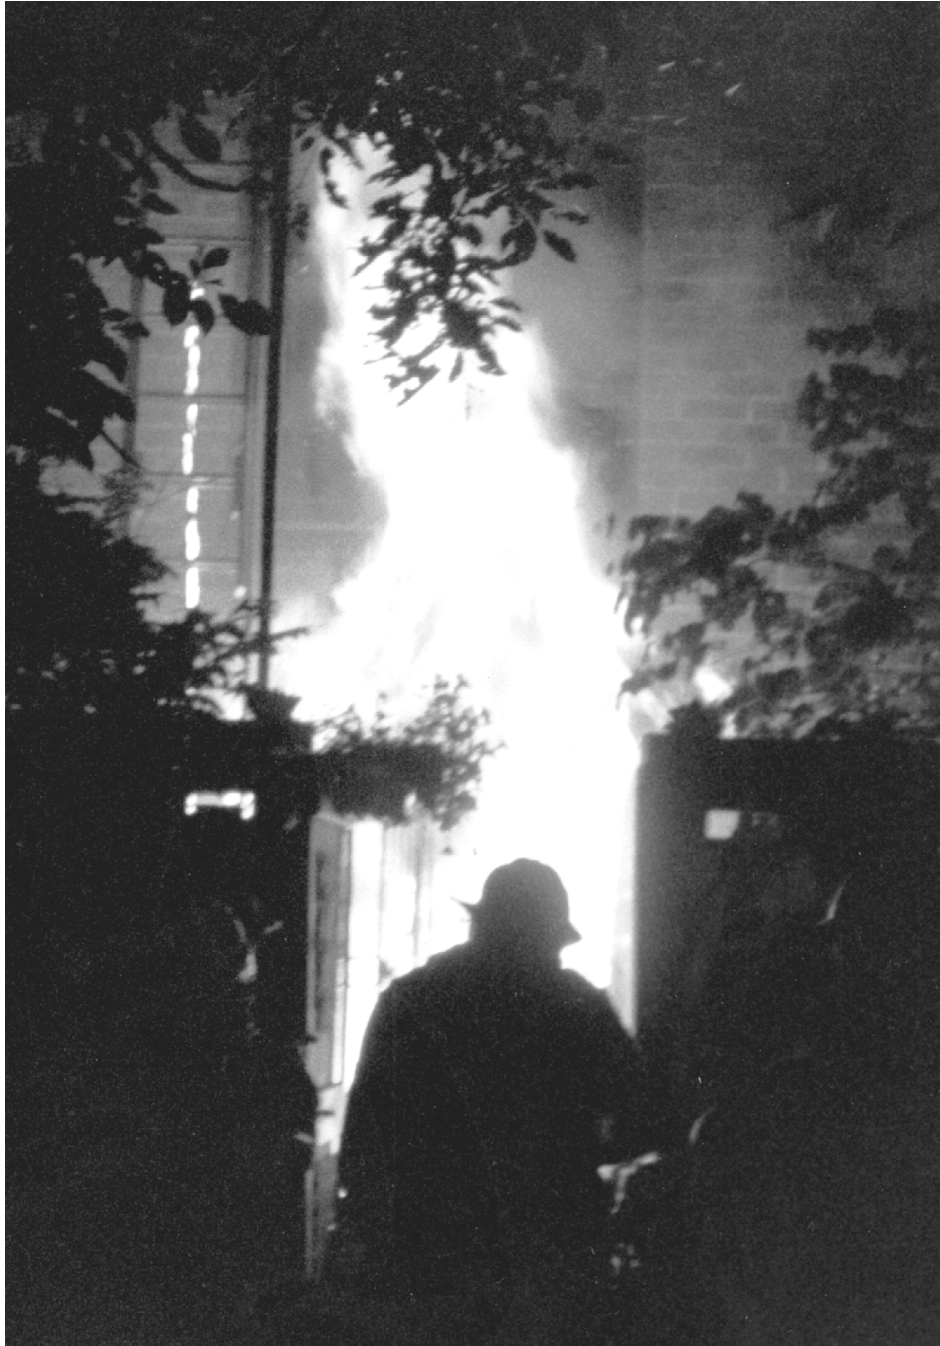
Photo 6 Fire conditions at the rear basement entrance as conditions deteriorate

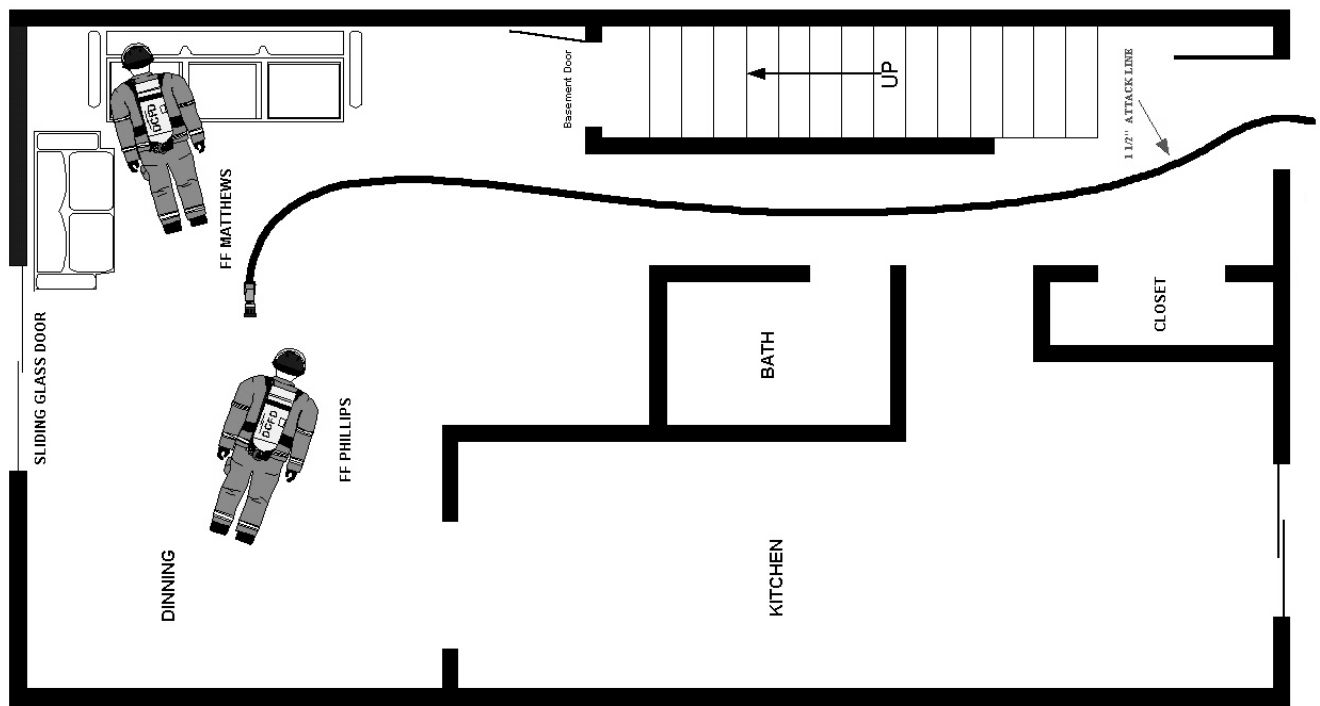
Fire Fighter Matthews, was located simultaneously by several fire fighters. Fire Fighter Matthews was found unconscious, leaning over a couch near the rear of the living room, his SCBA operating. Fire Fighter Matthews had not activated his manually activated PASS Alarm. At 00:49:40 hours, personnel from E-4, E-14, and the HMU removed F/F Matthews from the building, about 21 minutes after he was injured. Figure 5 shows the approximate locations in which the fatally injured fire fighters were found.

Figure 5 Location of downed fire fighters (Not to scale)

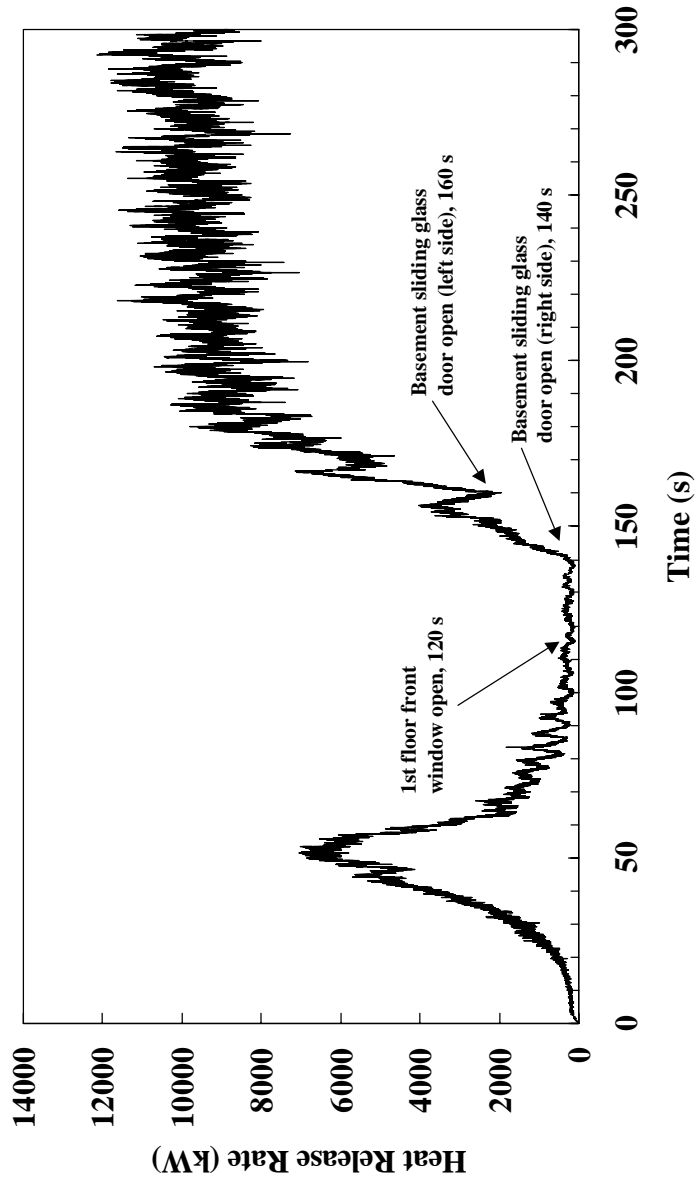
Figure 3. Heat release rate from FDS simulation.

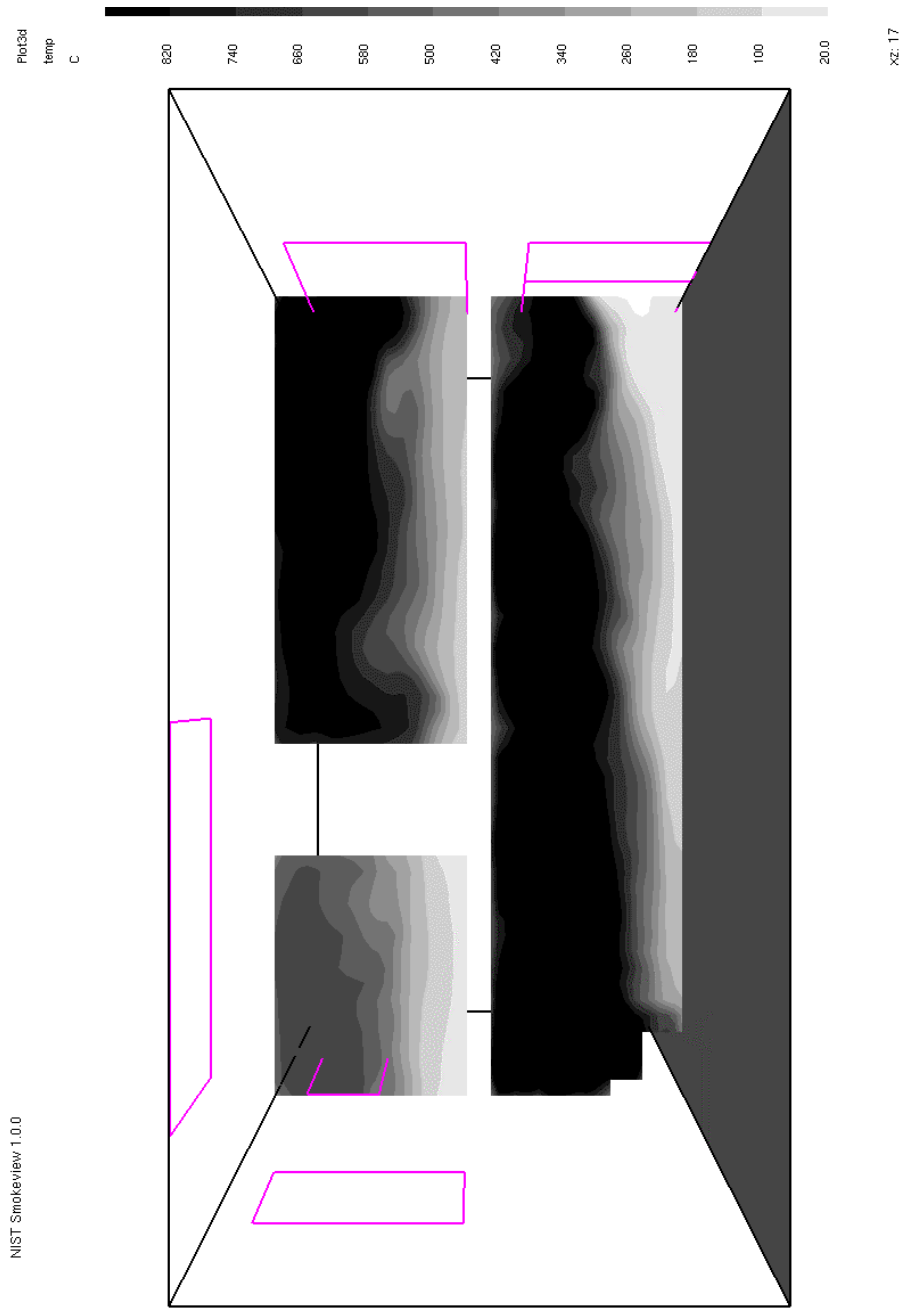
Figure 6. Temperature slice along basement sliding glass door, at 200 s of simulation.

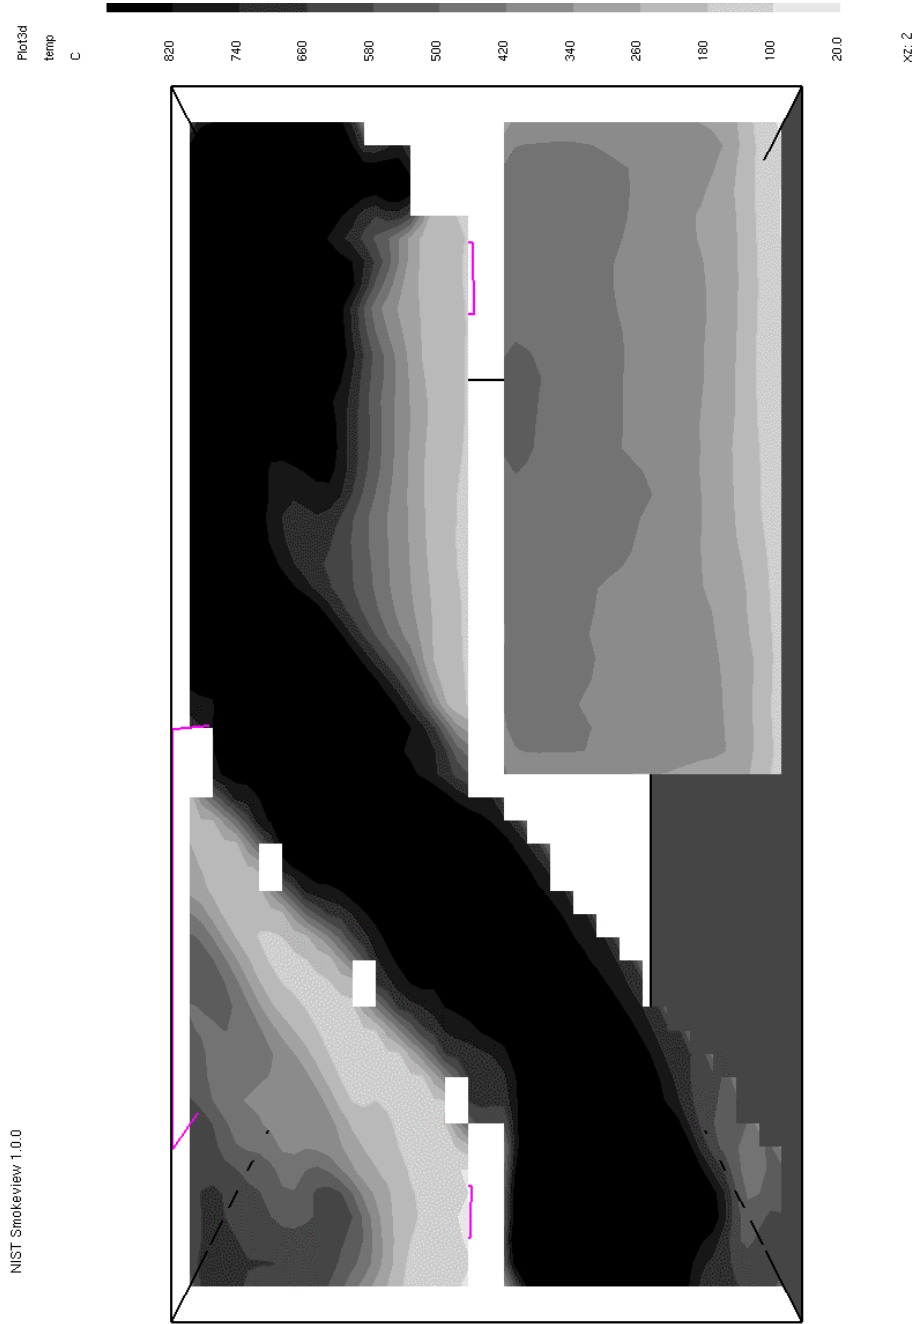
Figure 10. Temperature slice along centerline of stairway, at 200 s of simulation.

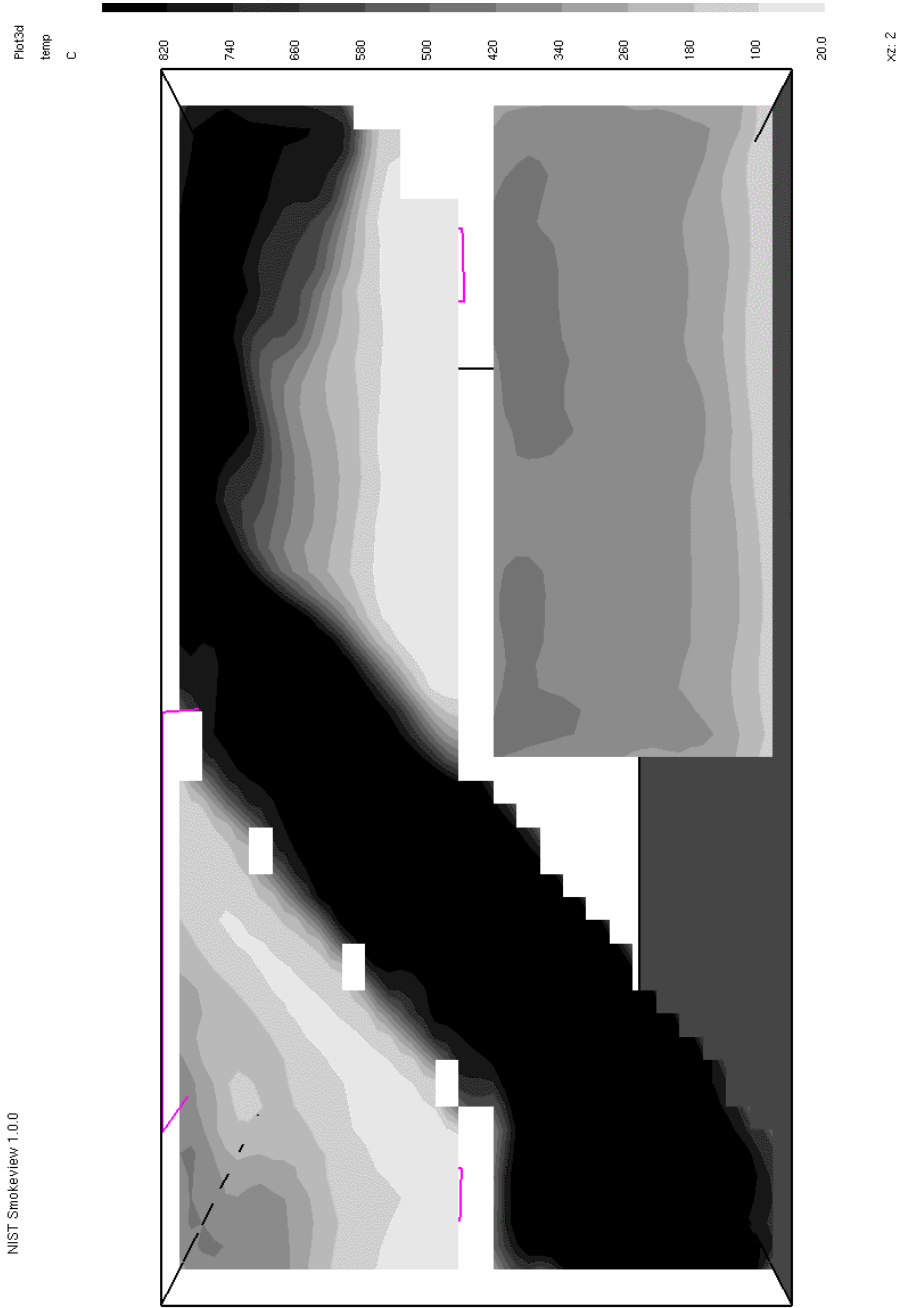
Figure 16. Temperature slice along centerline of stairway with first floor sliding glass door vented, at 200 s of simulation.
