Retail Store Fire Investigation
Chesapeake, VA
March 18, 1996
SUMMARY

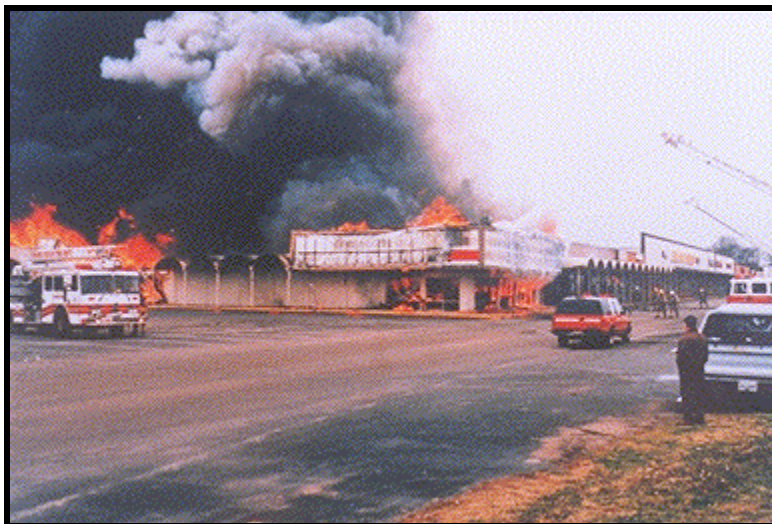
The building involved was approximately 12 years old. Two of the building's exterior bearing walls were constructed with unprotected steel frames and two were constructed with masonry block. Lightweight wood trusses with a clear span of 50 ft (15.2 m) supported the store's roof. Because the facility was an auto parts store, it contained a wide variety of combustible and noncombustible materials, flammable auto paints (liquid and aerosol), and other flammable and combustible liquids. Most packaging materials and some shelving materials were also combustible.

The fire occurred when a utility worker damaged the electrical service drop conductors on the outside of the store. Electrical arcing inside the store ignited fires that quickly involved the wood trusses supporting the roof and ignited a fire in the area of an electric hot water heater. Though some of the fire was visible to anyone in the occupied area of the building, much of the fire was hidden in the concealed space above the

store's ceiling, and the fire was able to spread in that area.
