Two Firefighters Killed in Auto Parts Store Fire Chesapeake, Virginia

**Two Firefighters Killed in Auto
Parts Store Fire
Chesapeake, Virginia**

(March 18, 1996)

This is Report 087 of the Major Fires Investigation Project conducted by Varley-Campbell and Associates, Inc./TriData Corporation under contract EMW-94-C-4423 to the United States Fire Administration, Federal Emergency Management Agency.

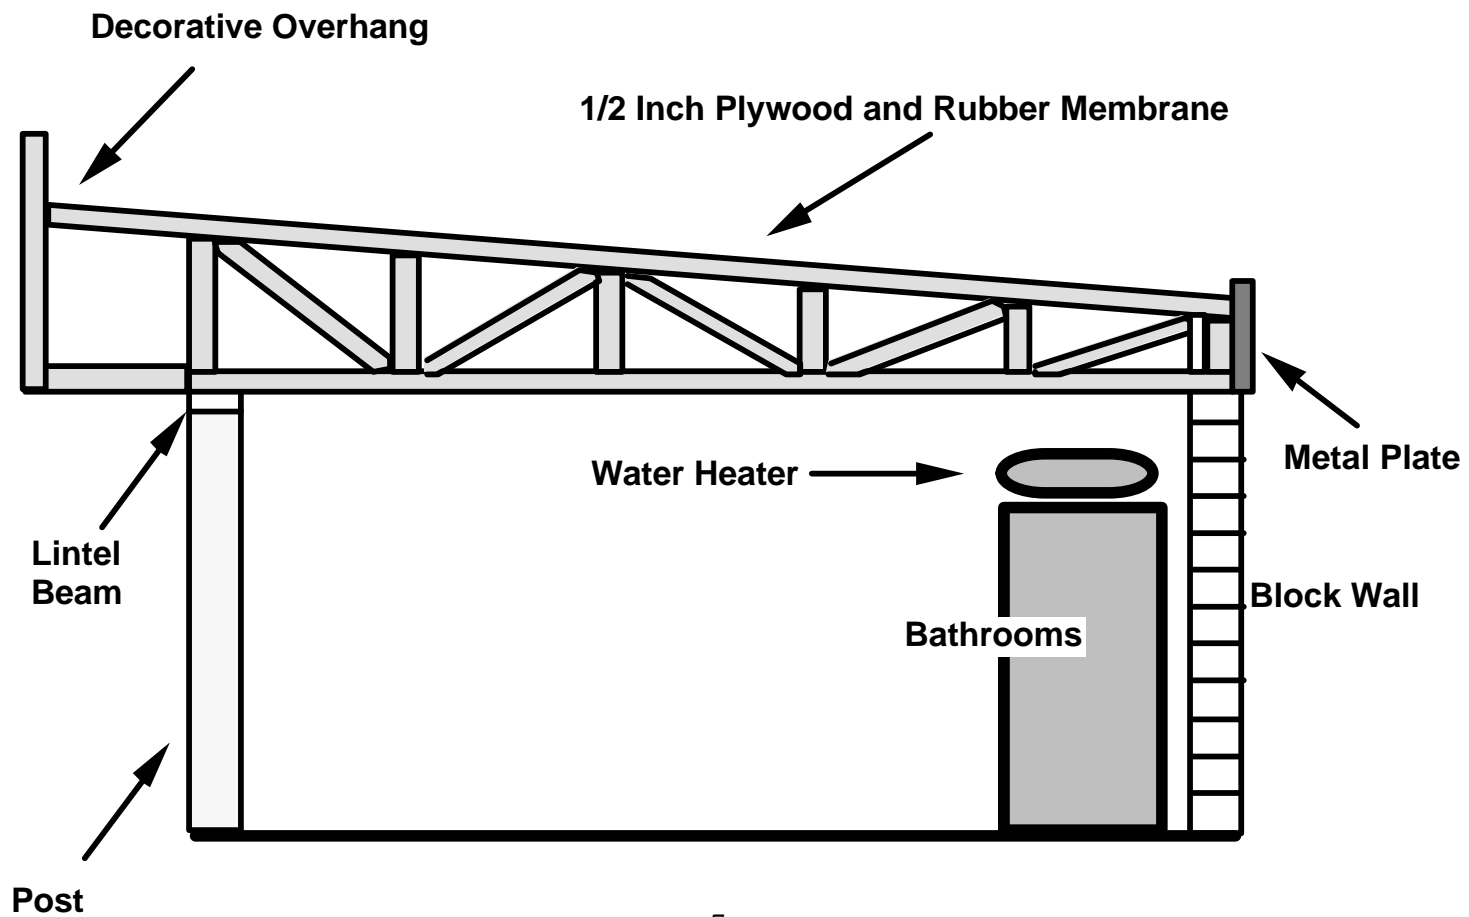
Figure 2
ADVANCE AUTO PARTS STORE
Dissection of the truss roof as viewed from front to back
of the building.

¹ Post incident investigations by the Chesapeake building inspector revealed that these ends may not have been properly secured to the beam.

Post-incident investigations indicate that this truss assembly may have been weakened by deficiencies in the connection of the trusses to the beam on the east side of the building. Also, the dead load of the three air conditioning units may have contributed to the rapid failure of the roof.

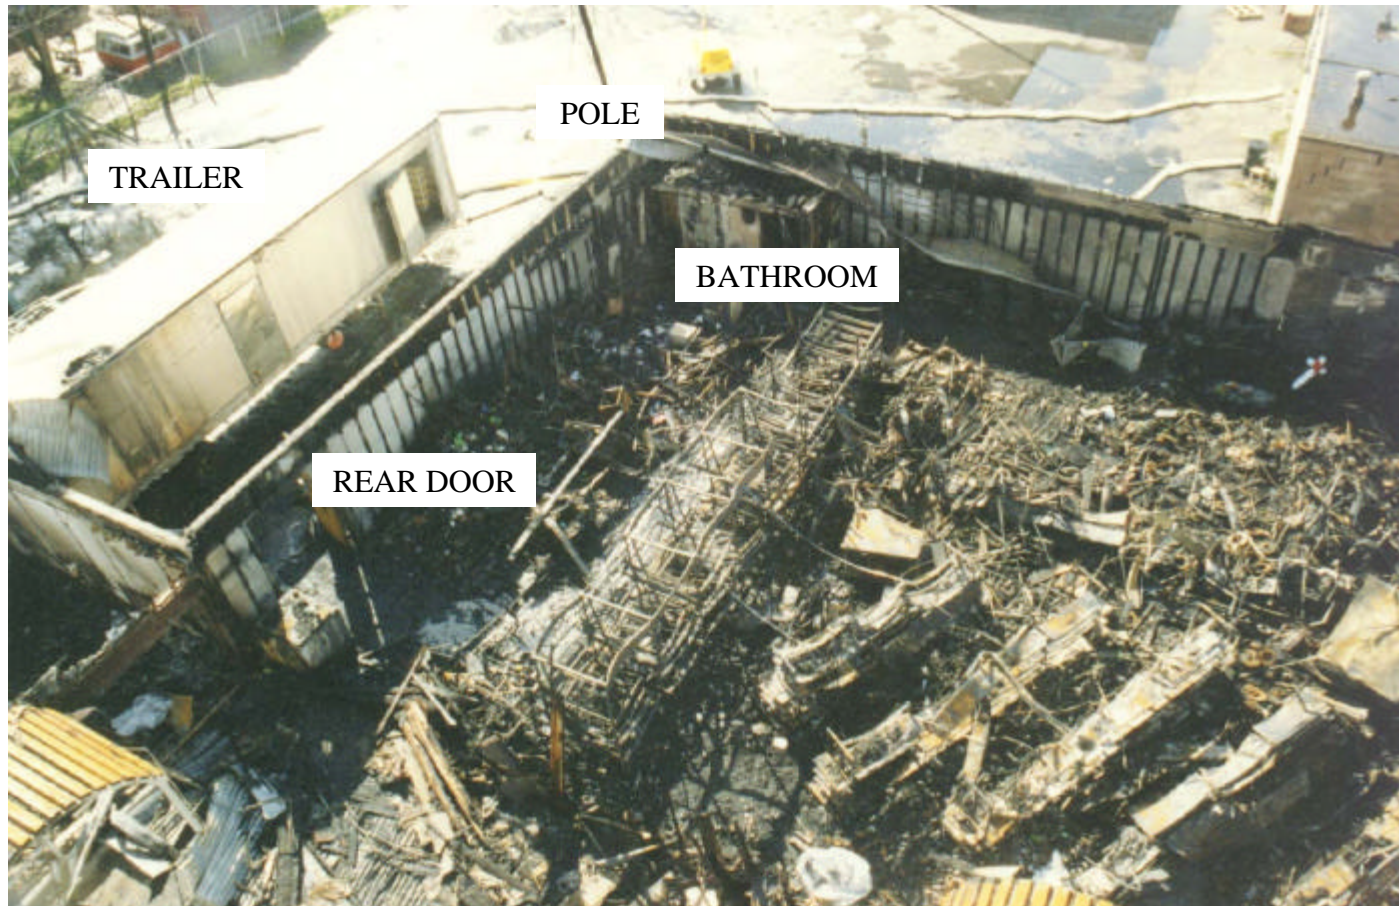
An elevated view of the rear of the store, showing (1) the door in the rear where the firefighters entered with the 13/4 attack line; (2) the trailer that blocked the view of the rear entrance; (3) the location of the utility pole; and (4) the employee bathrooms where the fire was originally discovered. *(Photo courtesy of the NFPA)*

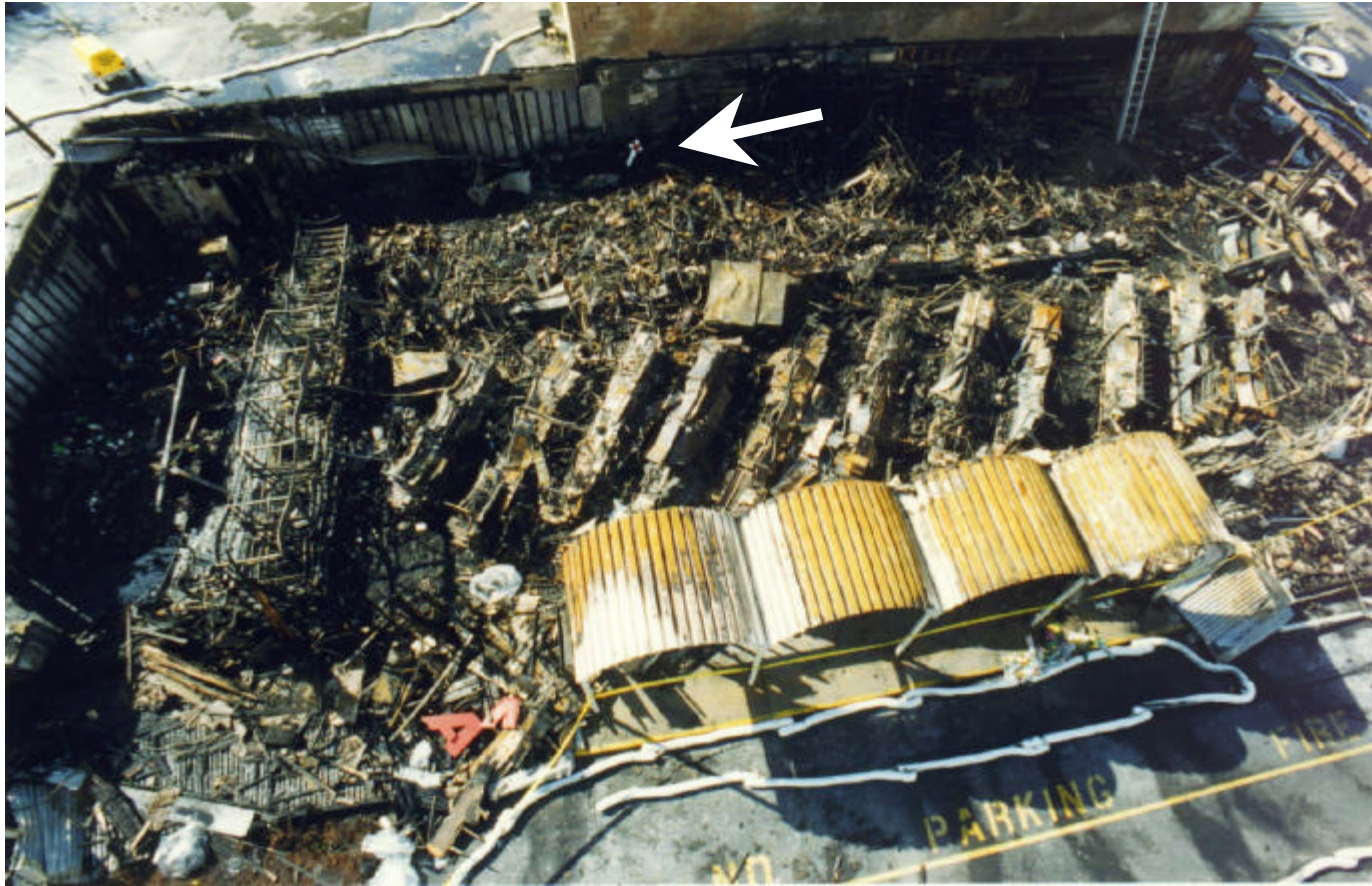
Photo of interior of the store from an elevated position on side two. The white cross (arrow) indicates where both firefighters were found. *(Photo courtesy of the NFPA)*

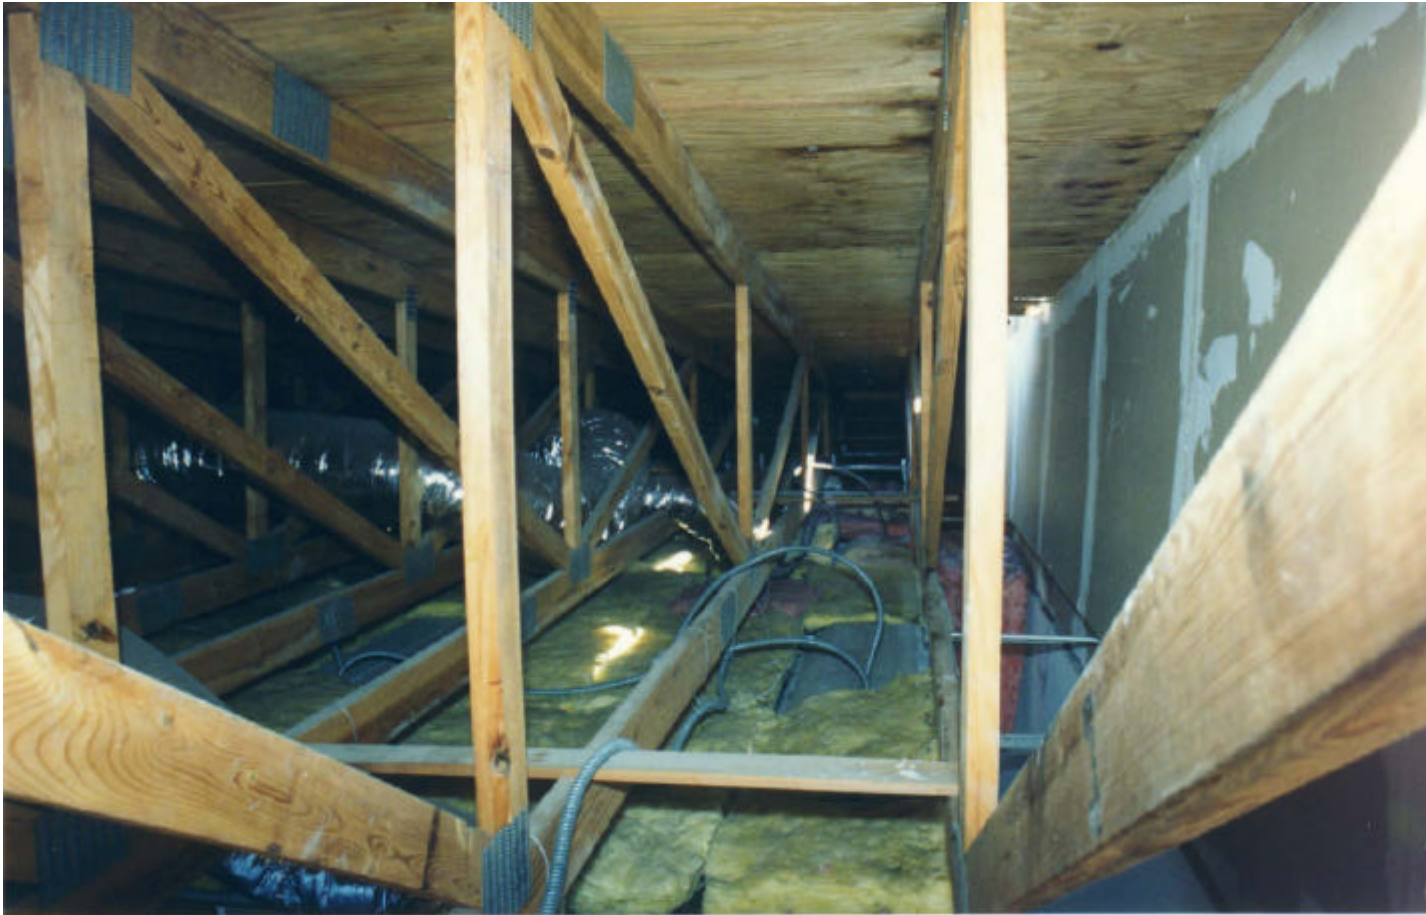
The truss loft area in another part of the Indian River Shopping Center. *(Photo courtesy of the NFPA)*

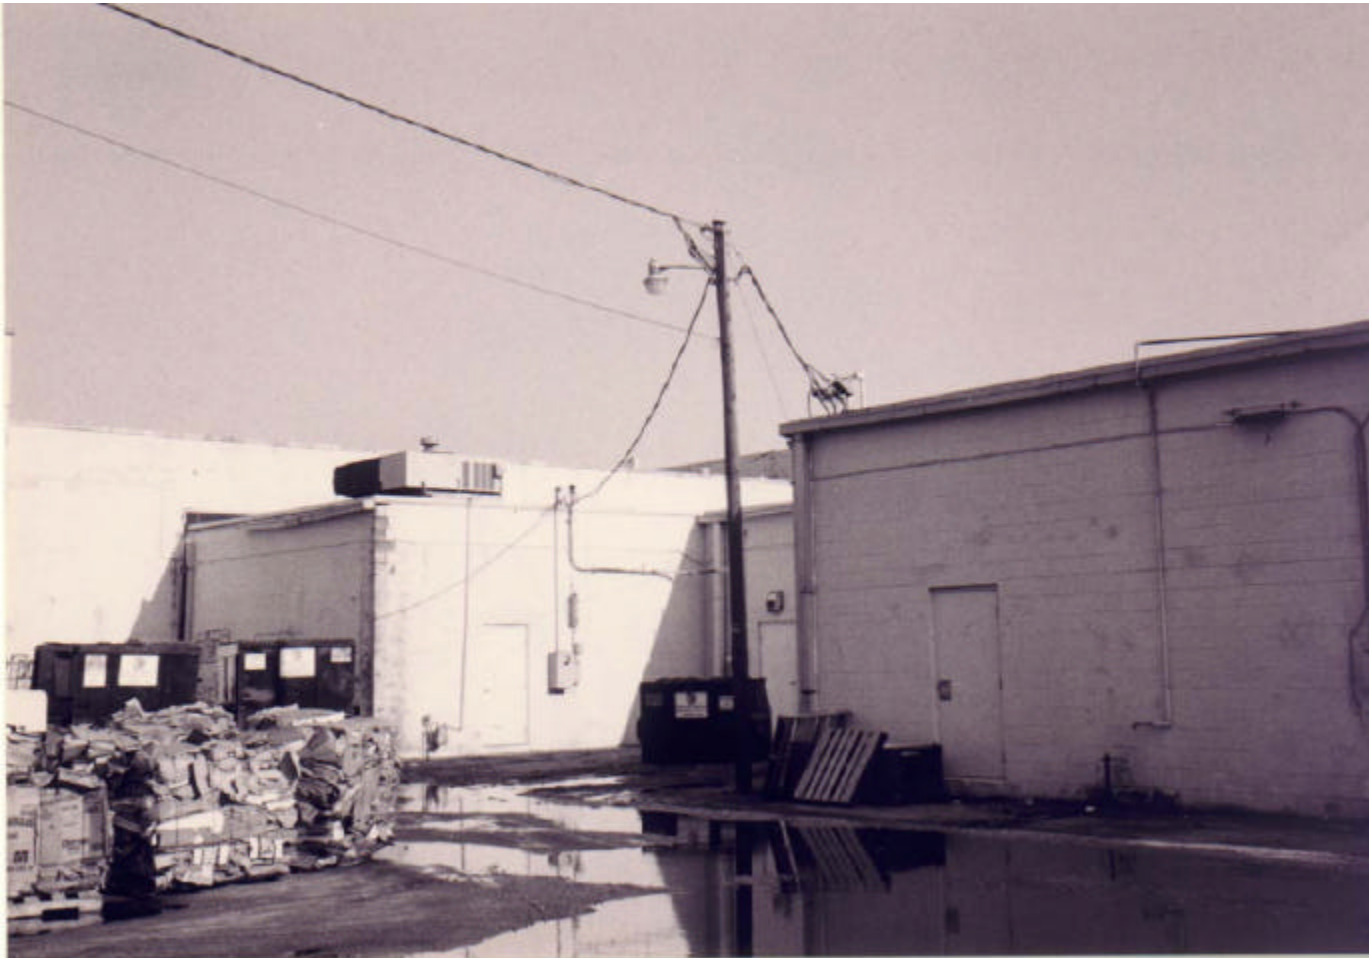
The fire was caused by the electrical short created when the power company truck struck the power line to the building. Investigation by the City of Chesapeake Electrical Inspector after the fire revealed that the meter contained wiring that appeared to have been tampered with and did not comply with the electrical code. Several connections at the meter had been double-lugged, connecting multiple wires to single terminals. Additional investigation by Virginia Power revealed that the building may have been improperly grounded, leading to numerous hot connections when the short circuit occurred. The main fuse did not trip at the breaker panel and the wiring on all three air handling units had been fused. This probably resulted in the ignition of multiple spot fires in the truss loft above the store.

Utility pole connecting power to a meter at the rear of the Indian River Shopping Center. (*USFA file photo.*)

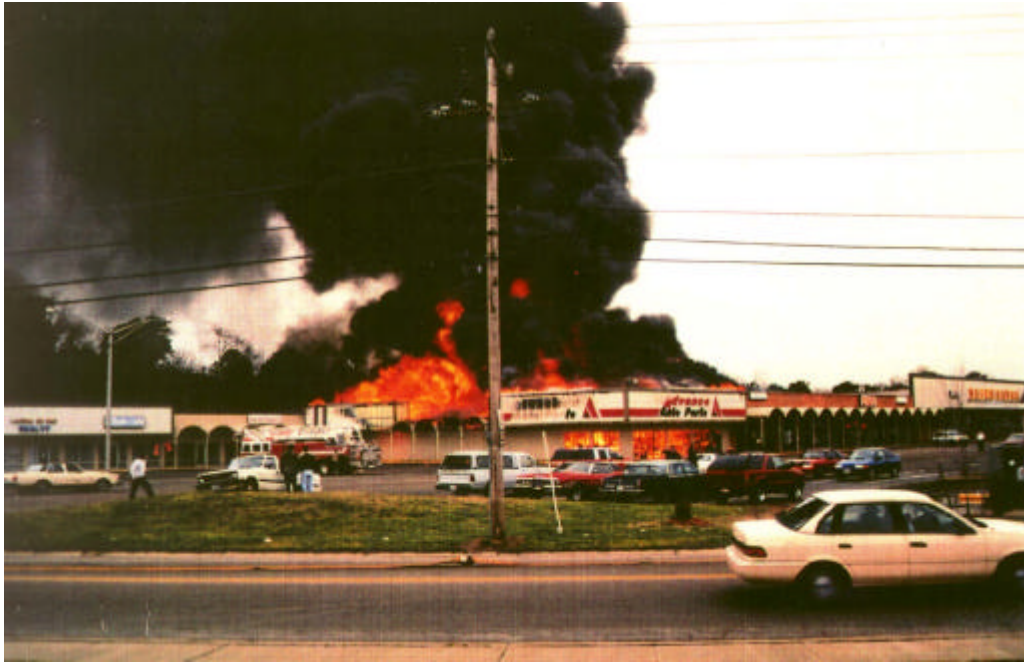
Ladder 2 is shown in its initial position on side two. Time of the photo is estimated between 11:50 and 11:52 a.m. (*Photo courtesy Chesapeake Fire Department*)

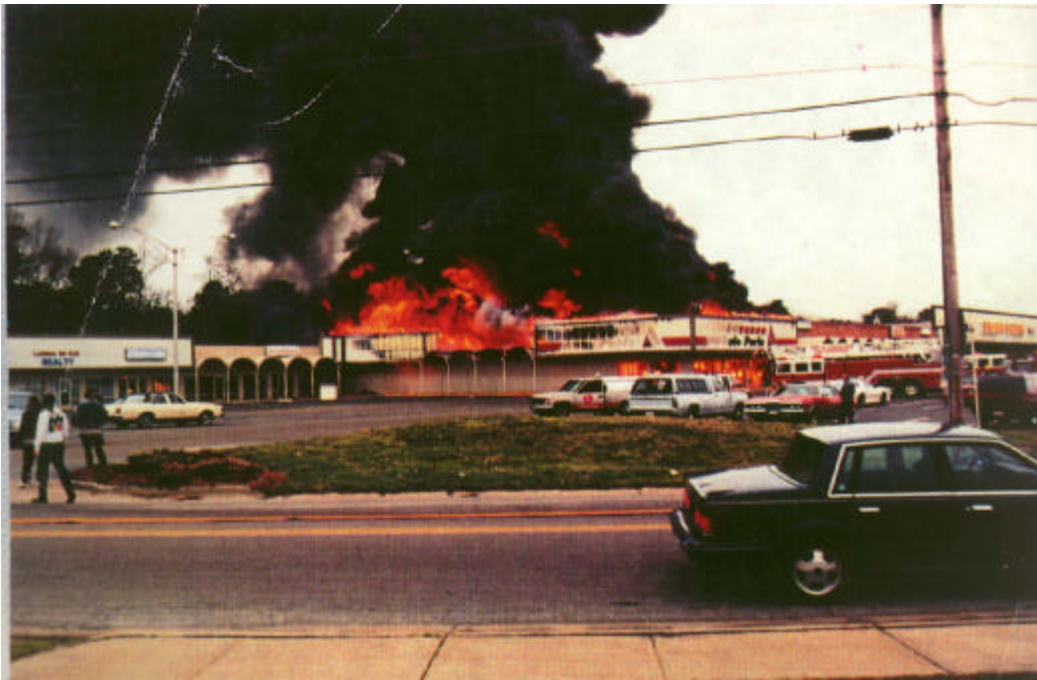
Ladder 2 is shown in position on side one. Time of the photo is estimated at 11:52 a.m. The supply line in the front of the picture is from Engine 1. (*Photo courtesy Chesapeake Fire Department*)
